Dam Safety

VOLUME 17 | ISSUE 2 | 2020

OROVILLE SPILLWAY

Personal Reflections on a Global Dam Safety Incident

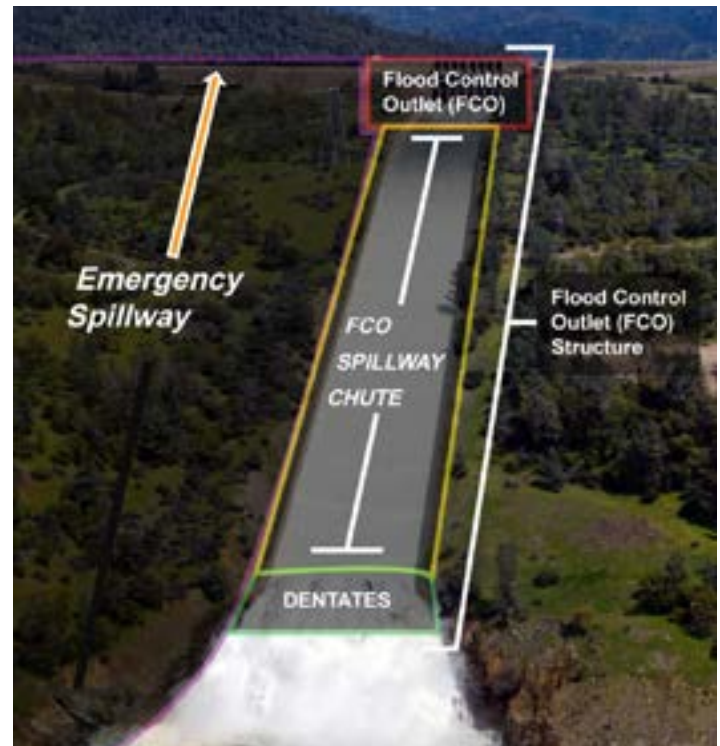
Figure 1. Flood Control Outlet Structure and Emergency Spillway

The project's two spillways include the Flood Control Outlet (FCO) structure and an Emergency Spillway as shown in Figure 1. The function of the FCO structure is to provide regular releases to support the flood protection mission of the project that protects the downstream communities. The FCO structure is designed to release 8283 m³/s (296,000 ft³/s) during the probable maximum flood (PMF), although actual owner operational plans limit the FCO discharges to about 4247 m³/s (150,000 cfs) due to the downstream levee capacity. The FCO spillway has three main structural components as shown in Figure 1: a gated Flood Control Outlet, a 1310 m (4300 ft) long spillway chute, and an energy dissipater ("dentates"). The chute is a rectangular, reinforced-concrete open-channel chute that closely follows the original natural terrain. FCO discharges enter the Feather River.

The uncontrolled Emergency Spillway was designed to discharge extreme floods to prevent overtopping of the main embankment dam. The Emergency Spillway consists of two sections; an ogee section and a low-height sill weir adjacent to the public-access parking lot. The ogee section consists of multiple concrete monoliths founded on bedrock with varying heights. The tallest monolith has a height of about 16 m (50 ft) from the original ground, and excavated into a shear zone down to rock for a total structural height of 90 ft. The Emergency Spillway was sized to release a maximum flow of 10,506 m³/s (371,016 cfs) when the reservoir elevation is at 297.5 m (917 ft) enabling the combined project to pass the PMF.

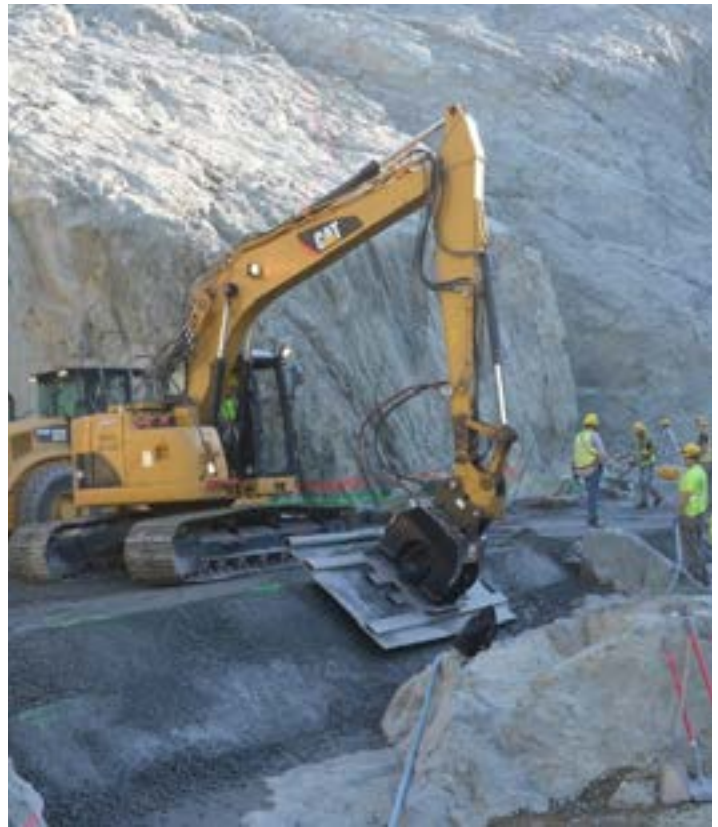
Figure 3. RCC Side Slopes formed at 1:1

The RCC design offered two key challenges. First, we didn't have enough time to form the outside slopes, which would typically be done for an RCC dam. At the Olivenhain RCC Dam in San Diego completed in 2004, the downstream side of a portion of the dam was left unformed at a 1:1 slope. I took that experience, knowing that the RCC could stand on the natural angle of repose, and used it for the design of the left and right sides of what would come to be a new RCC chute. The actual construction of this 1:1 side slope is shown in Figure 3, which the Contractor (Kiewit Infrastructure) constructed using a custom fabricated steel plate on a vibrating head that compacted and sealed the 1:1 slope.

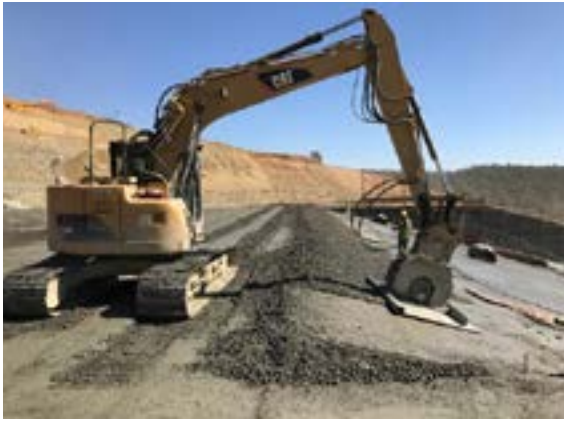
Left: Figure 4. Rough RCC Chute Forming

The biggest challenge, however, was creating a rectangular chute with vertical side walls on a 4H:1V chute slope. RCC is typically placed in 30 mm (1-ft) thick lifts and had never been used for such an application as steep, smooth sloping spillway chute. We came up with an approach to form a rough chute surface using horizontal placements with a flat plate vibrator to seal the 4:1 slope as shown in Figure 4. The general construction of the RCC chute is shown in Figure 5.

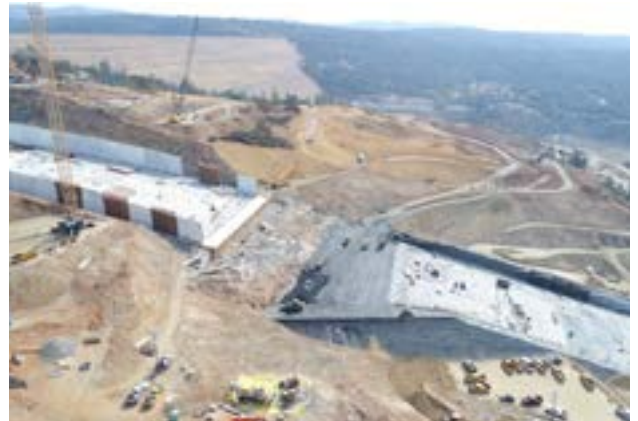
Right: Figure 5. General construction of the RCC chute (Courtesy of DWR)

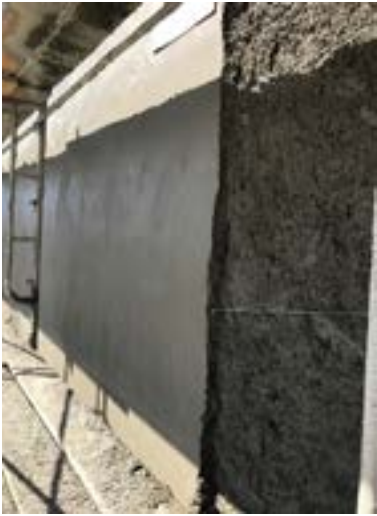
Above: Figure 6. Hilfiker Basket Forming of Vertical RCC Chute Walls

The inside vertical side walls posed a significant design challenge as forming such large vertical walls on a 4:1 chute slope had never been done before using RCC. The performance specification left it open to the contractor to develop an innovative and cost-effective solution. In the end, the contractor used a methodology typically used for stabilized earth walls developed by Hilfiker ("a Hilfiker basket"), which worked very well once the inside wall was covered with shotcrete as shown in Figures 6 and 7.

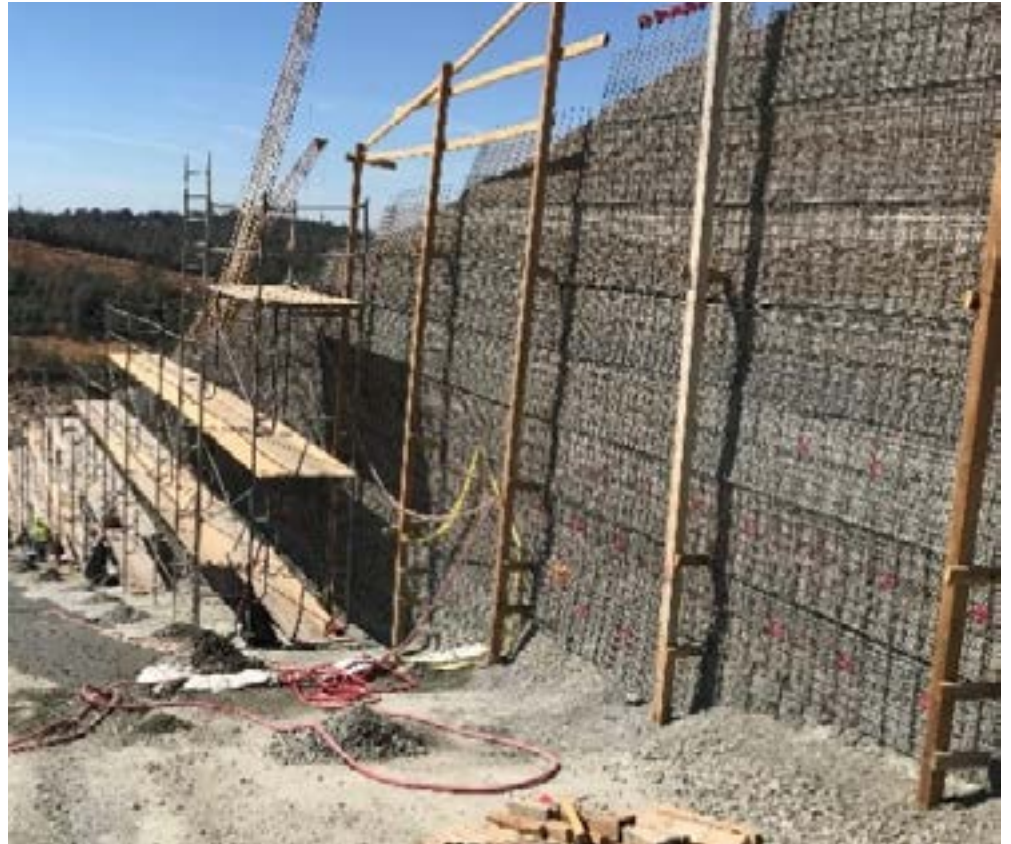
Right: Figure 7. Shotcrete at Inside of Hilfiker Walls

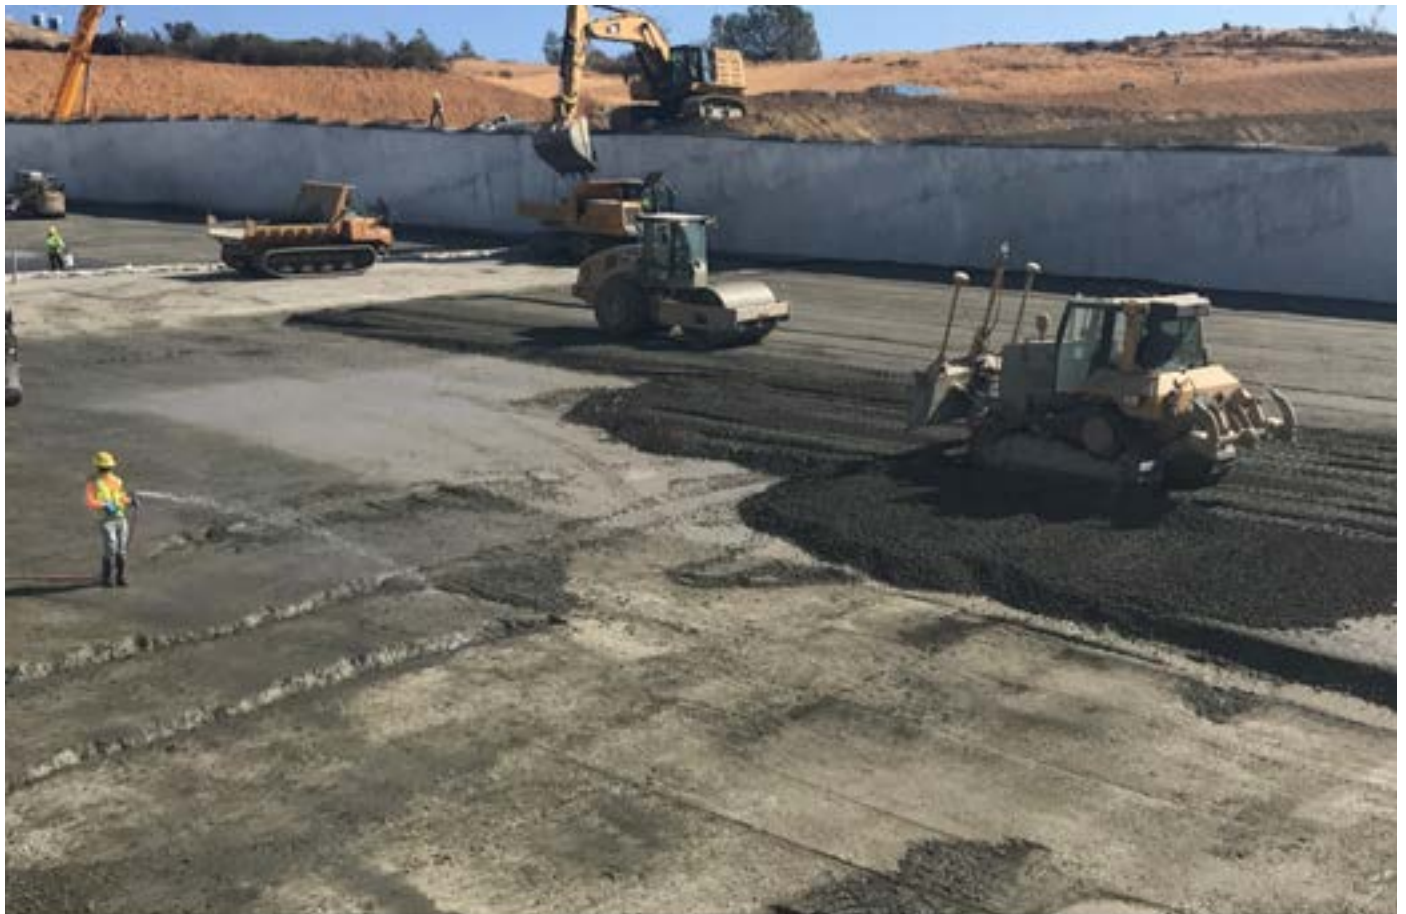
Figure 8. Final Placement of Enriched RCC on Steep 4:1 Chute Slope

Once the inside walls were complete, all that remained was a final chute surface. Since the temporary chute would be available for the 2017-2018 winter flood season, we wanted to have a strong surface to resist the erosive forces of high flows down the chute. The basic foundation replacement RCC material was designed for 3500 psi at one year, but the top surface needed to have a strength of 3500 psi at 28 days of age to be available on December 1. A 30-mm (1-ft) thick "enriched" RCC layer was designed with a higher cement content to meet the early strength requirement. The enriched RCC was installed as an overlay to the basic RCC material as shown in Figure 8. This approach of placing RCC on a steep 4:1 slope had never been attempted. The contractor worked with DWR and the engineer to come up with an innovative approach using standard RCC placement equipment along with specialized Marooka trucks with tracks and a rotating cab that perfectly suited work on the steep chute slope.

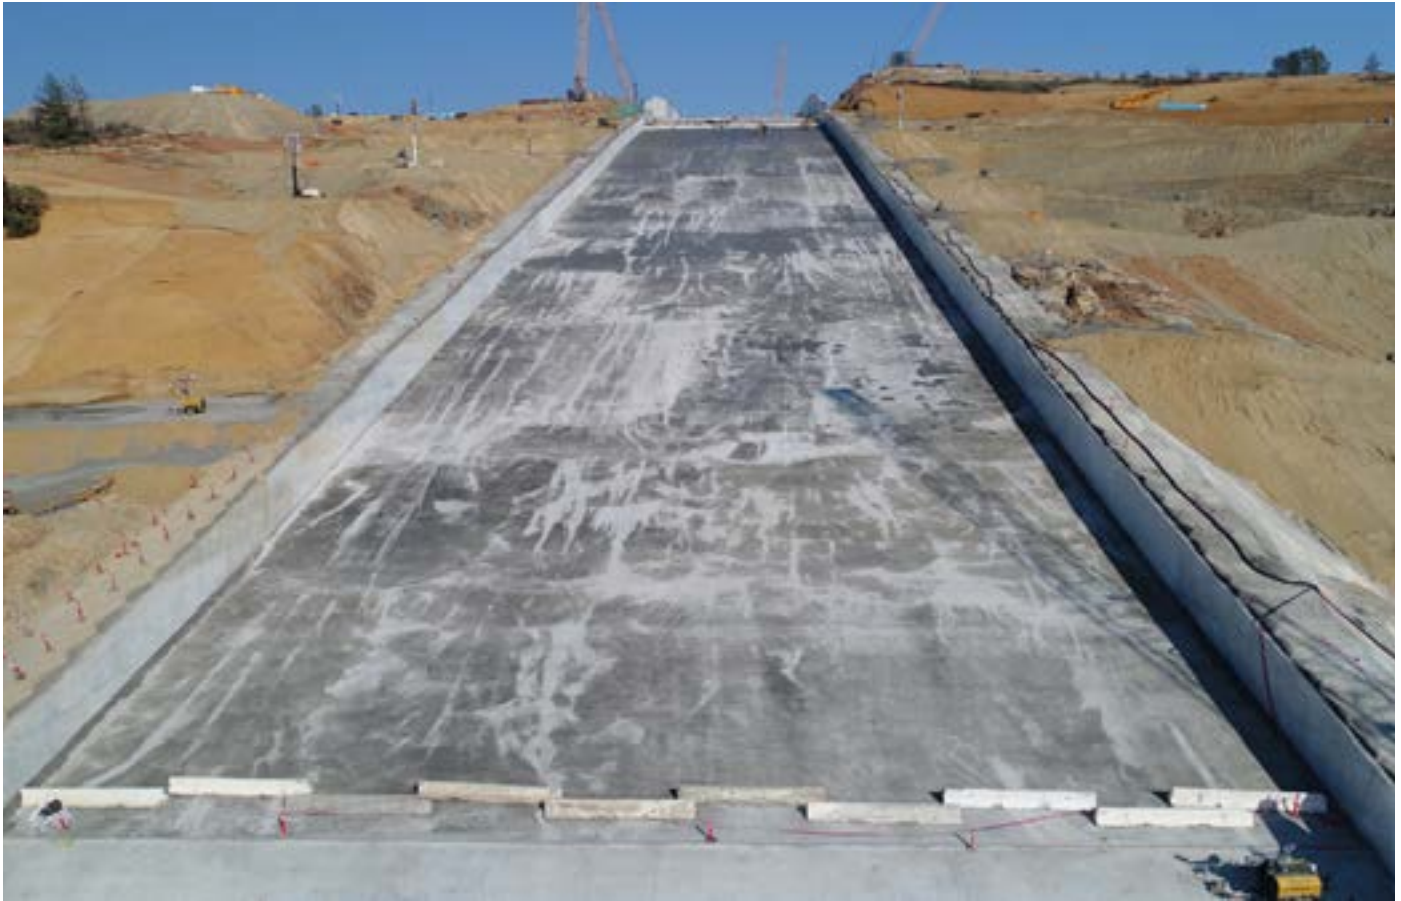
Figure 9. Completed RCC Portion of the FCO Chute (Photo from DWR, November 2017)

The completed FCO Spillway chute portion composed of RCC is shown in Figure 9.
